CARR - 679

910 MEDFORD ROAD

## FIELD SHEET--HISTORIC RESOURCES SURVEY

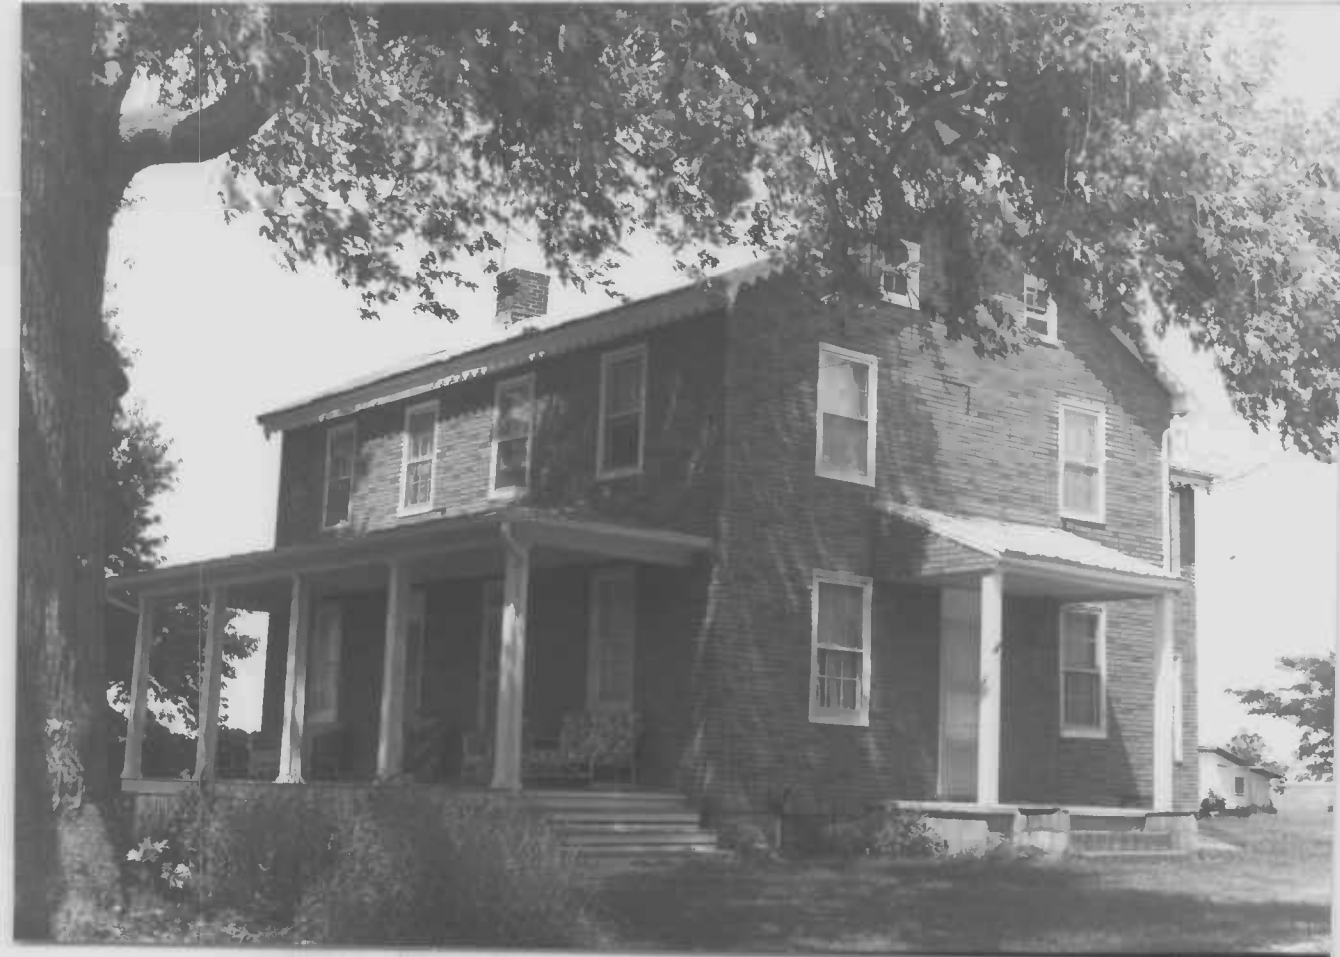
1. CARR-679 910 MEDFORD ROAD
2. Carroll County, Maryland
3. Joe Getty
4. August 1983
5. Md. Historical Trust, Annapolis, Md.
6. South and east elevation (camera  
facing northwest)
7. 1/1
